A MANUAL FOR RE-ENGINEERING LIVING SHORELINES TO HALT EROSION AND RESTORE COASTAL HABITAT IN HIGH-ENERGY ENVIRONMENTS

October 2018

To address this issue, a team of researchers and natural resource managers implemented a project, funded through the NOAA National Estuarine Research Reserve System Science Collaborative program, which evaluates the efficacy of a novel living shorelines technique to mitigate coastal habitat erosion along high-energy shorelines. The project team designed a hybrid structure that acts as a double barrier to dissipate boat wake energy along the Atlantic Intracoastal Waterway in Ponte Vedra Beach, Florida. This technique consists of a set of wooden breakwalls placed in front of oyster structures along a dynamic shoreline. The breakwalls act as a first line of defense against boat wakes while the oyster structures serve as substrate to restore oyster reefs that can further dissipate wave energy. Within this manual are the project details, including results from testing the hybrid living shorelines technique as well as explanations of planning, design, installation, maintenance, monitoring, and costs.

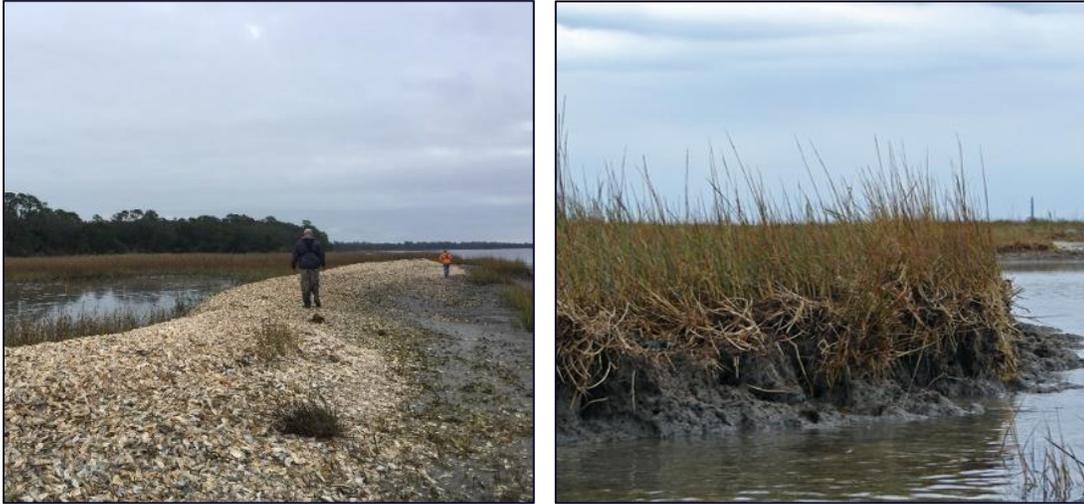
Figure 3: Oyster shell rake (left) and saltmarsh erosion (right)

Historically, extensive Eastern oyster (*Crassostrea virginica*) reefs populated the intertidal margins of this estuary, but due to heavy boat traffic, only dead shell mounds (also called “rakes”) now occur along the ICW channel edge (Figure 3, Appendix B). Live oyster reefs are widespread in tidal creeks and inlets that experience lower levels of boating activity in the area. Oyster larval supply in the area is abundant during the peak reproductive season, which lasts from April through September (Figure 4).

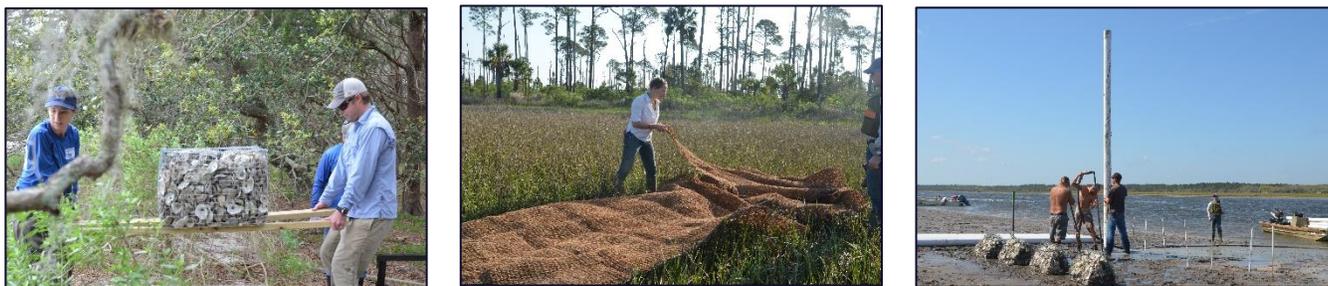
Figure 5: Transporting large gabions (left); coconut fiber mat (center); installing piling (right)

- *Shape of oyster gabions* –Large triangular and rectangular cages were used at the pilot site to test stability in high wave energy. These heavy gabions were logistically challenging to transport (Figure 5), so smaller (50 x 20 x 15 cm) rectangular cages were used at remaining sites and deployed by volunteers.
- *Coconut fiber mat* – At the pilot site, tree branches were wrapped in coconut fiber mats that degraded over time (Figure 5), so branches were wrapped with wires at remaining sites.
- *Breakwall structures* –Large PVC pilings were installed at the pilot site for the breakwall frame using jet drilling from a barge (Figure 5). Given the difficulty of installation and permanence of the deep-set PVC, wooden fence posts were used at remaining sites installed with mallets by hand.

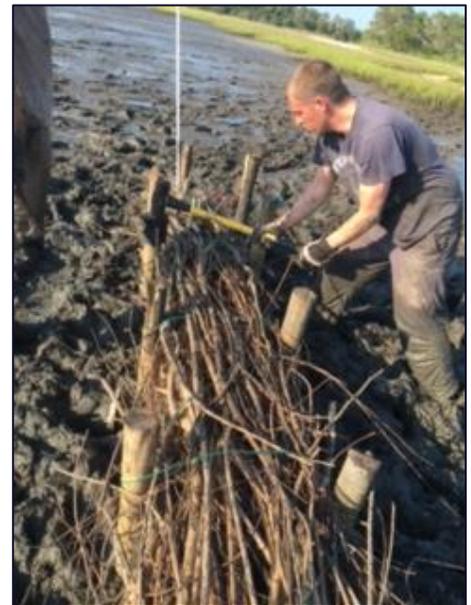
Figure 7: Project team installing fence posts using wood mallets

Plastic-coated multipurpose wire and fence post nails held the tree branches within the fence post wall frame. Each breakwall was built by first installing a set of fourteen wooden fence posts arranged in two rows of seven posts (Figure 6). Fence posts were driven at least 0.6-m into the ground using augers and large wooden mallets and positioned into a rectangle, leaving a 61-cm space between adjacent posts (Figure 7). Gas augers can also be used if the sediment is more sandy than muddy. Once the posts were installed, the space inside the wall was filled with tree branches spread evenly across the length of the wall (Figure 7).

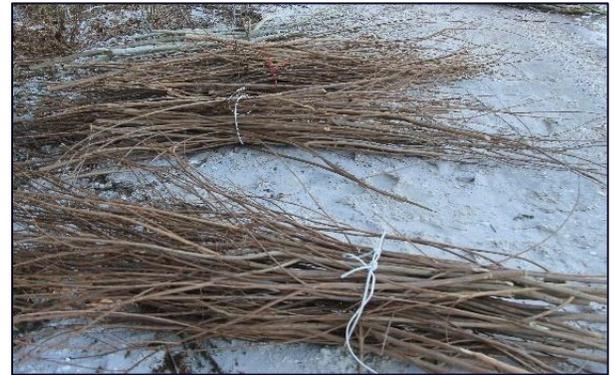
Figure 8: Bundles of crepe myrtle branches

The tree branches used for this project were crepe myrtle (*Lagerstroemia* sp.), but other tree species may be used (Figure 8). Crepe myrtle branches were chosen because it was a locally available, abundant, easily transported, and inexpensive resource. Crepe myrtle branches were also found to resist biofouling better and weigh less than live oak branches. For additional information about the relative vulnerability of crepe myrtle, laurel oak, sweetgum and black mangrove branches to biofouling and shipworms, please see Appendix D.

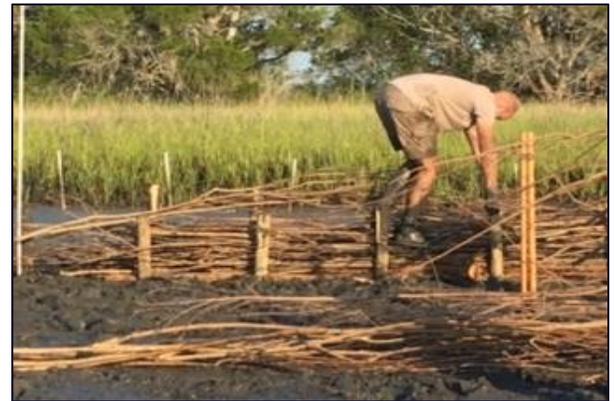
Figure 9: Adding tree branches inside the fence posts and compressing until packed

Tree branches inside the fence posts were stacked to roughly twice the desired height (i.e. 76.2-142 cm high). The tree branches were then compressed by stepping on top of the branches until they were tightly packed within the fence posts (Figure 9). With the branches compressed, a second person began securing the branches in place with the plastic-coated multipurpose wire (Figure 10). To do this, the multipurpose wire was woven in a zig-zag pattern across the branches along the length of the wall while pulling on the wire to tighten it and secure it with a U-shaped fence nail at every post.

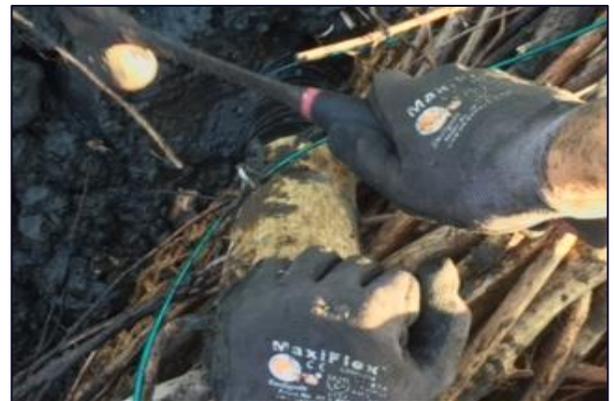
Figure 10: Compressing tree branches and securing with wire to fence post

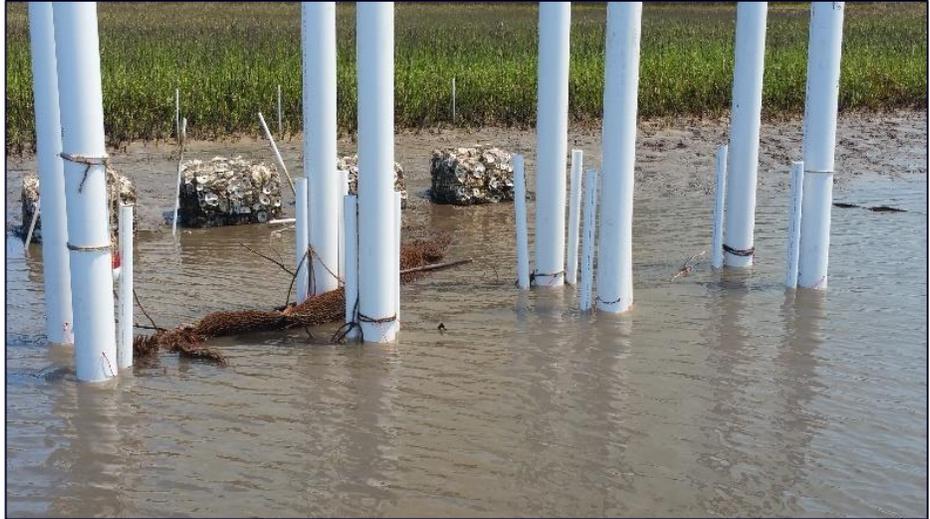
Figure 16: Branches missing from the pilot site; likely missing due to wave energy

The most immediate threat to the breakwalls is the dislodgement of tree branches resulting in a loss of wall height (Figure 16). The high-energy conditions of the environment and the loosening of the multipurpose wire around the branches may cause the branches to be washed away. The wall height must be surveyed seasonally and if there is a substantial decrease in height from one monitoring period to the next, additional branches should be added and secured in place.

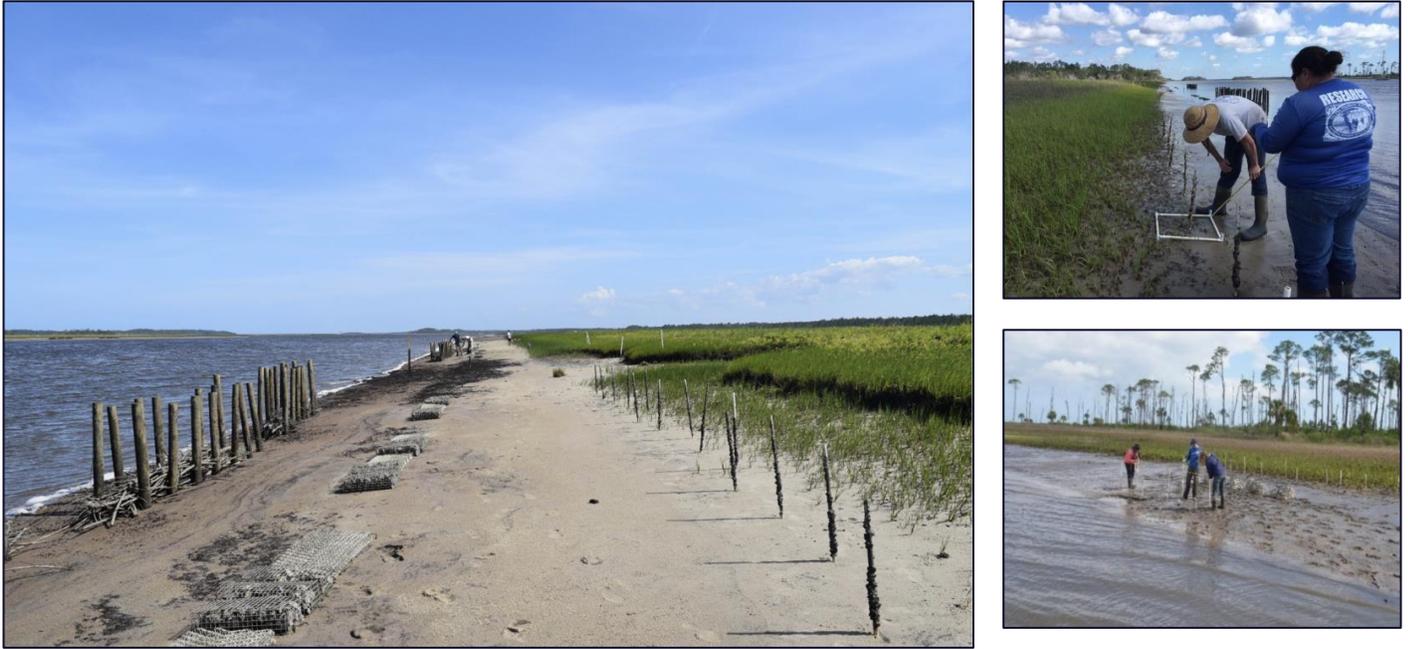
Figure 17: Photograph showing full experimental setup and monitoring structures. PVC poles on the right mark the initial shoreline position and the spots selected for ecological monitoring.

Prior to the construction of this project's living shoreline structures, each site's leading edge of the marsh was marked (defined as the point where the cordgrass vegetation terminated) along three 14-m-long segments of shoreline using 15, 2.5-cm-diameter x 0.9-m-long PVC poles that extended 0.5 m above the surface and were spaced 1 m apart. PVC poles were

numbered 1 through 15 starting at the northernmost point at each site (Figure 17). These markers were used throughout the project to monitor the shoreline edge pre- and post-construction. Distances were measured from each PVC pole to the most seaward cordgrass stem and patch of peat allowing an evaluation of whether the shoreline was retreating, advancing, or staying the same.

Ground cover data was collected for each shoreline segment at a subset of five of the PVC poles along each shoreline section. Ground cover measurements were taken from a 0.5 m x 0.5 m quadrat positioned 1) at the PVC marker indicating the shoreline edge (0 m), 2) 1.5 m behind/landward of the marker, and 3) 1.5 m in front/seaward of the marker. Within each quadrat, the percent ground cover of sand, peat, root mat, shell hash, and live oyster on the sediment surface was visually estimated to evaluate whether surficial sediment composition was shifting over time (Figure 17).

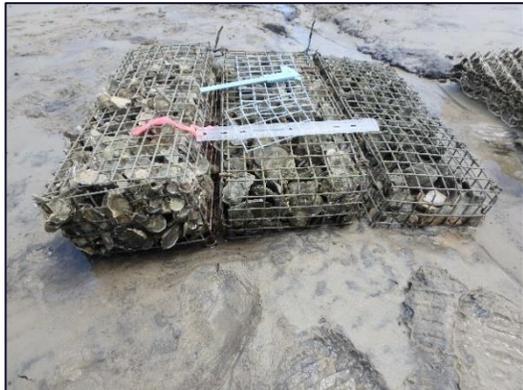
Figure 18: Oyster measuring equipment on three small oyster gabions

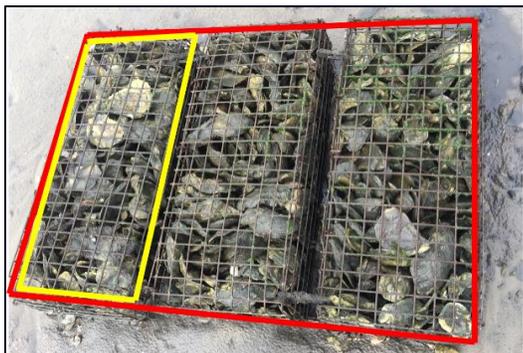
Figure 19: Larger oyster gabion set is outlined in red and small, individual oyster gabion is outlined in yellow

To monitor oyster density and size in the oyster gabions, three small oyster gabions were randomly selected from each of the two types of wave breaks at each site. One small, individual oyster gabion (Figure 19) was removed from each larger gabion set. The contents were emptied into a fish box and the shell height of live oysters was measured. The shells were then rinsed to remove sediment and debris (Figure 20). All shells in the smaller oyster gabion were counted and 25 of those shells were haphazardly chosen for measurement. All live oysters on the 25 selected shells were counted and measured (shell height to nearest mm) with calipers or ruler. After processing, all shell and live oysters were placed back into the smaller oyster gabion which was returned to the larger gabion from which it was taken. Live oyster density (# oysters/0.1 m²; and # oysters/0.015 m³) was determined using the equation below.

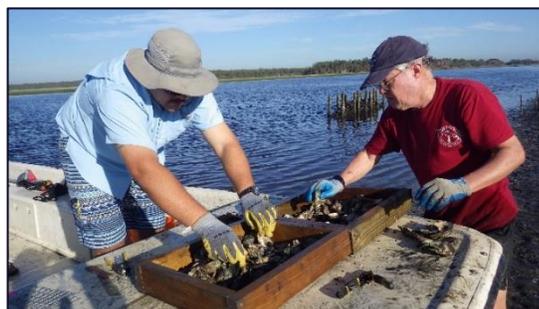
Figure 20: Sorting oysters from smaller oyster gabion for size measurements and density calculations

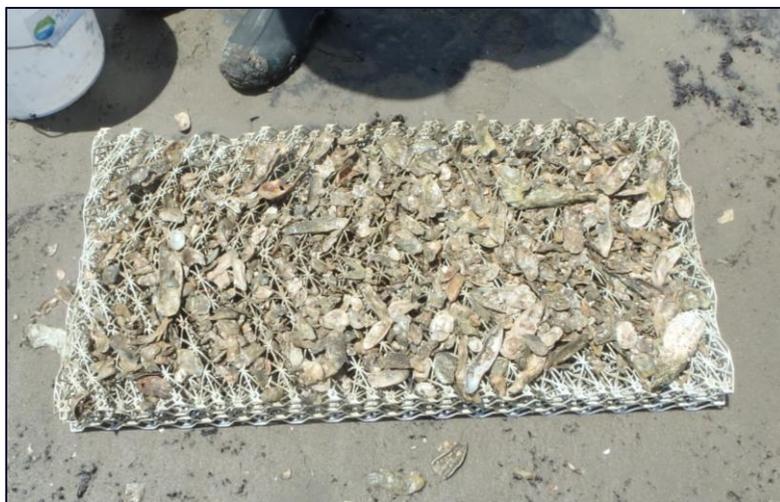
Figure 21: BESE-elements® with shell material added to recruit oyster growth

The project team planned to monitor oyster density within the BESE-elements®, however the oysters did not grow on the bare BESE-elements®. After a monitoring event, the project team added oyster shell to the BESE-elements® to recruit oyster growth (Figure 21). In the future, to monitor oyster density and size in the BESE-elements®, three BESE-elements® would be randomly selected from each site. A 0.015 m³ portion with the same dimensions as each smaller gabion (50 cm length x 20 cm width x 15 cm height = 0.1 m² surface area) of each of the selected BESE-elements® would be removed and processed as described above for the oyster gabions. After processing, all oysters and BESE-elements® material would be reattached to the larger BESE-elements® from which they were taken using cable ties from the same biodegradable material that the BESE themselves are constructed from.

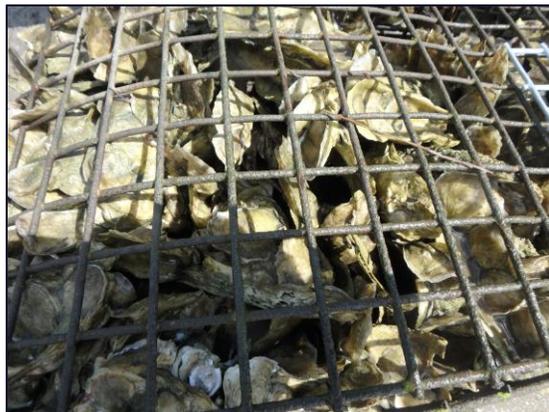
Figure 22: Oysters within the gabions

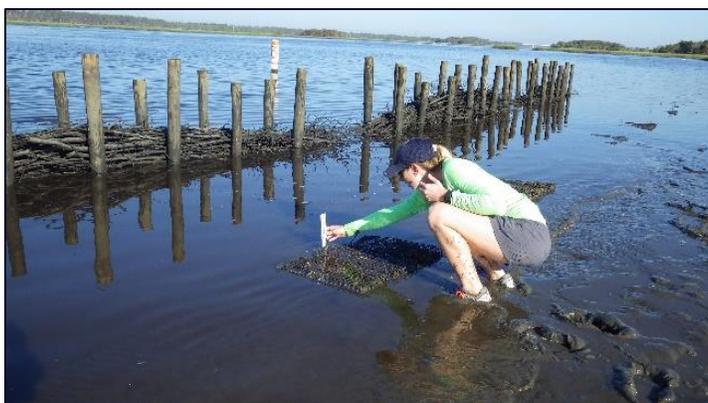
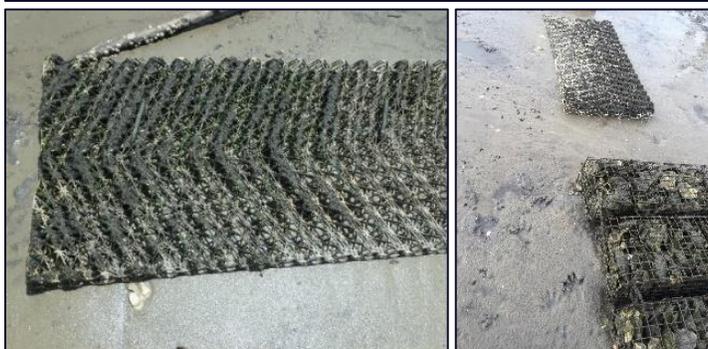
Figure 23: Measuring vertical distance of sediment (top); green algae growth on BESE-elements (bottom-left); and raccoon tracks landward side of the structures (bottom-right)

The observed condition of the oyster gabions and BESE-elements® was characterized by visual inspection, with notes and photographs of degradation of wire or materials (rust or deterioration), movement from original position, and sediment buildup and/or subsidence (Figure 23 and 24). Measurements and photos were taken on three randomly selected oyster gabions or BESE-elements® behind each of the two types of wave breaks (tall and short), yielding a total of six assessed experimental substrate units per site.

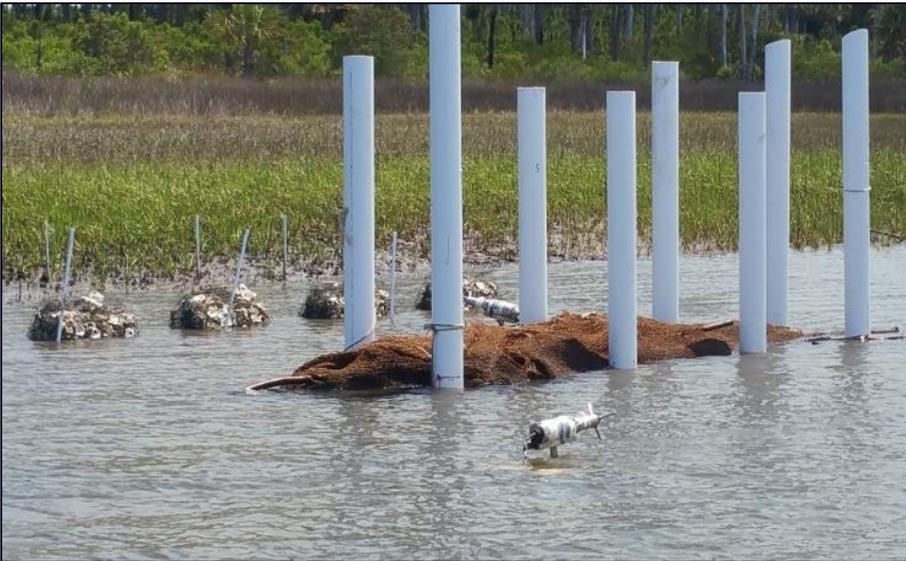
Figure 25: Pilot site gabion breakwall with wave energy gauge

This project not only focused on the salt marsh and oyster community, but also the wave/wake climate of the ICW, including bathymetry and hydrodynamic data collection (Figure 25). At three sites, bathymetry data was collected to create three-dimensional plots of the ICW and slopes.

Several hydrodynamic instruments, including Acoustic Doppler Velocimeters and Acoustic Doppler Current Profilers, were deployed to record pressure and flow velocities on the landward and seaward sides of the breakwalls to assess the wake climate and evaluate the wake energy dissipation by the breakwalls. Additional information can be found in Herbert et. al (2018).
